Some Geological and Geophysical Aspects of the 2016/2017 Drilling Campaign in the Windhoek Aquifer

Roy MILLER¹, Robert CARR², Ben VAN DER MERWE³, Gregory SYMONS⁴,
Ricky MURRAY⁵ & Martha AMPUTU⁶

Keywords: Windhoek aquifer; Groundwater; Faulting; Drilling; Water management; Auas Formation; Kleine Kuppe Formation

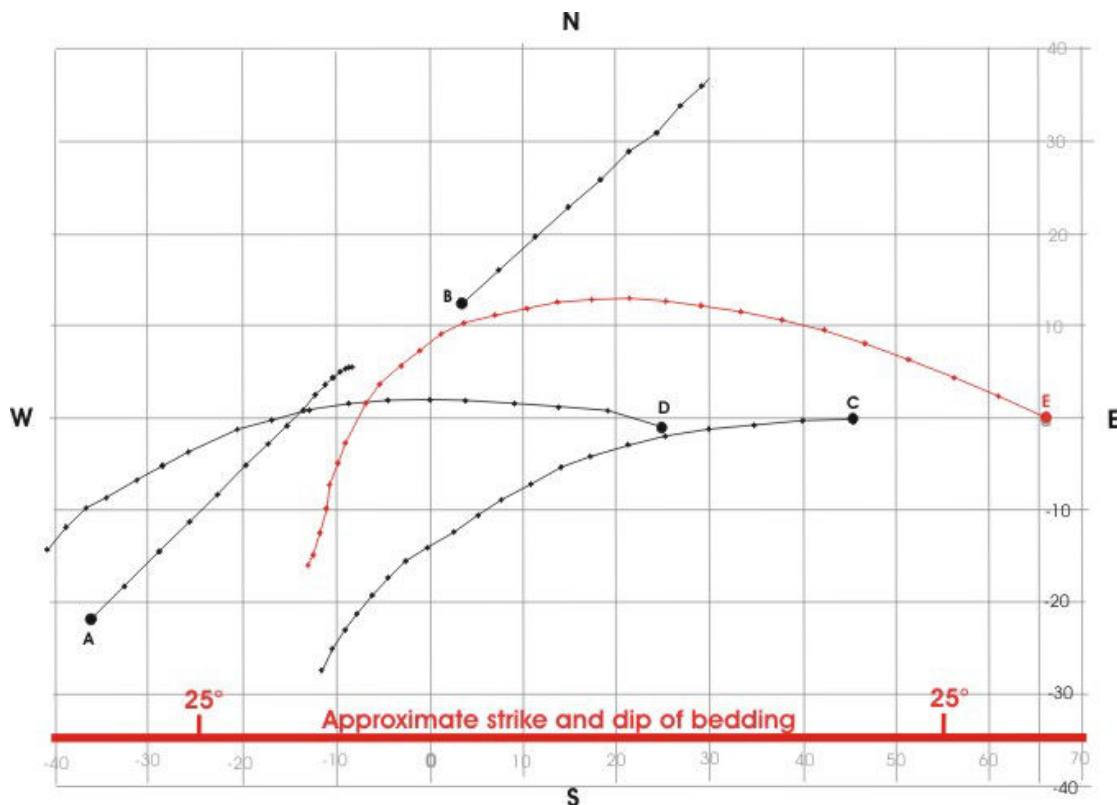
Figure 4. Plan of paths of inclined probe boreholes showing how they deviated in depth away from their initial orientation.

the faults and thus parallel or at a low angle to strike of the bedding. In almost all cases deviation of the hole was unpredictable and varied from probe to probe (Fig. 4). Once dip of a fault had been determined from the inclined probes, it was necessary to drill a vertical probe to determine how the larger diameter, vertical, production hole would probably deviate. All probe and production holes deviated from their initial orientation and it was essential to survey each and every one over its full length in order to determine the exact location of key intersections in 3D space.
